**FIELD REPORT:** Vessel S45, Contract Number R-1609

Work Order WE003, Item 8001

**FIELD REPORT:** Vessel S45, Contract R-1609

Component damage repairs

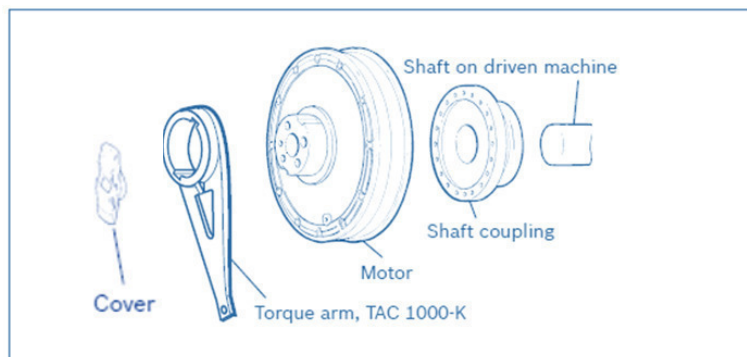
1. Marking and decoupling of hydraulic lines
2. Removal of front cover
3. Removal of torque arm
4. Removal of crimp rings' coupling
5. Removal of hydraulic motor's rear cover
6. Withdrawal of hydraulic motor

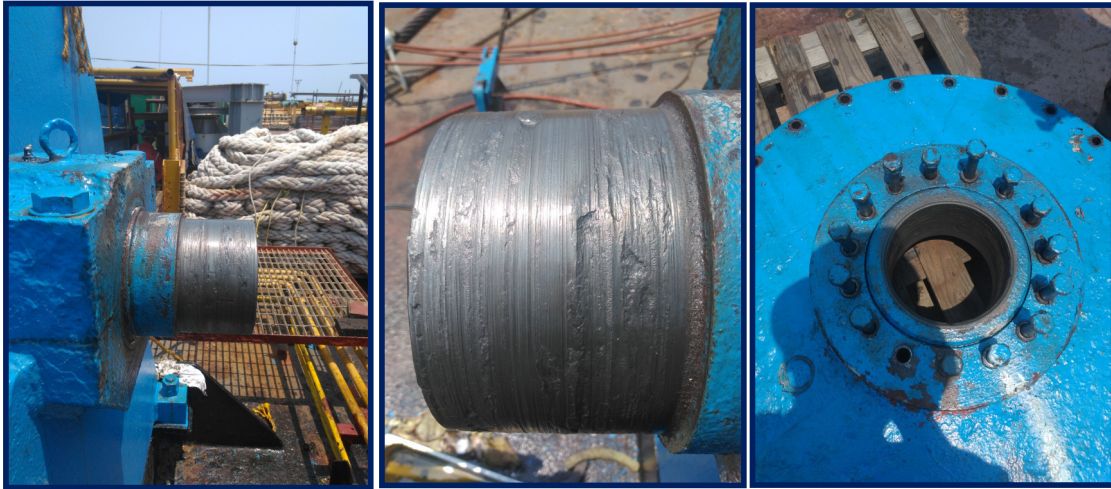
After withdrawing the hydraulic motor, mooring winch drum shaft and hydraulic motor coupling housing are observed to be damaged; DRAGGING OF MATERIAL (contact surface extremely rough) from friction.

A misalignment between the crimp rings' coupling and mooring winch drum shaft was generated causing a transmissible axial force or torque variation therefore causing friction and damage to both components.

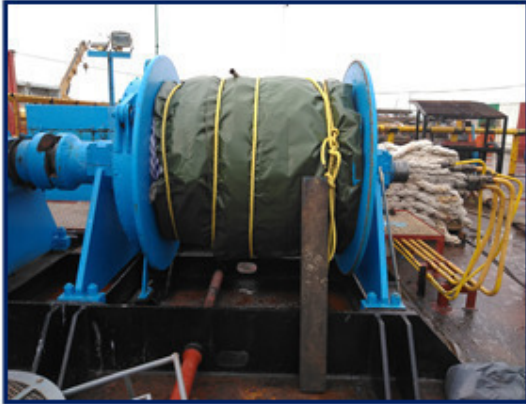
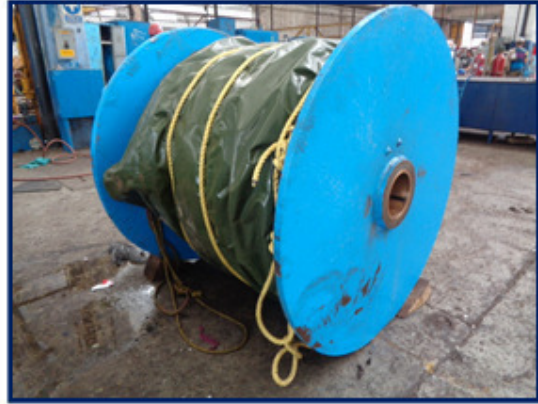
Mooring winch drum was dismantled and transported to workshop. It was then dismantled at the workshop removing coupling-clutch and solid shaft. One of the two bronze bushings of the drum was found to be stuck against the shaft, rotating along with the shaft inside the drum housing. This was shown to the Shipowner for him to make a decision.

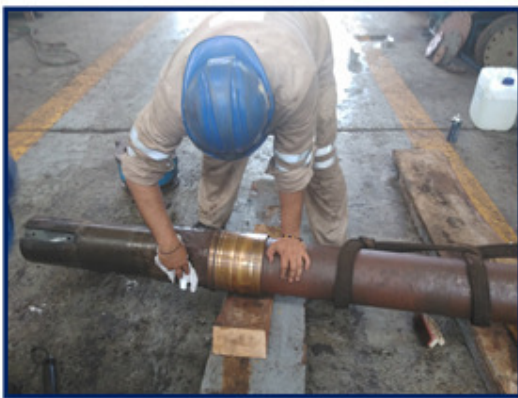
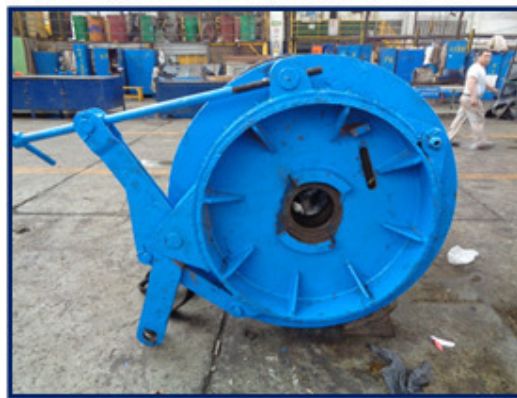
Solid shaft was sized and turned while removing adhered and loosened off material as a result of dragging (Report to be delivered by Machining Supervisor)

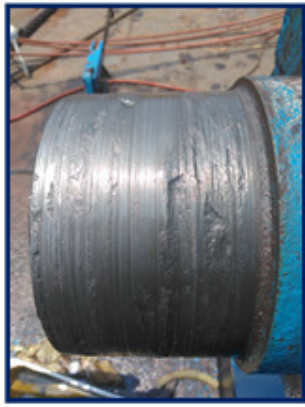
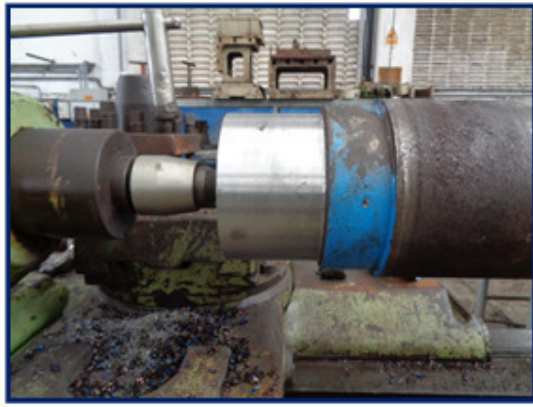
Hollow shaft was sized and turned (housing of the winch's solid shaft), to remove adhered and loosened material as a result of dragging material (Report to be delivered by Machining Supervisor), leaving ready for repairing and installing a duly welded and later machined bushing.

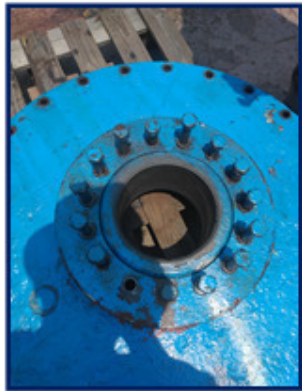
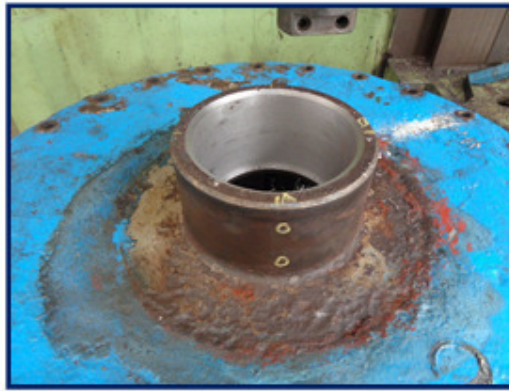
Conditions of crimp rings' coupling was shown to Shipowner who was informed that to reuse it and for the sleeve to be able to fit with a greater transmissible axial force or torque to the solid shaft, a 1 mm cut would be made at its joint (parallel to this, a request to quote new coupling was made). Lacking a new coupling, proposal was accepted.

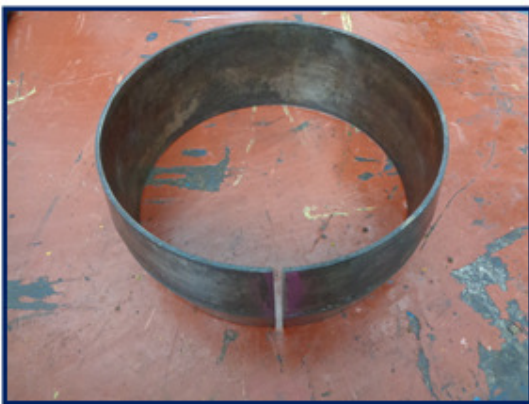
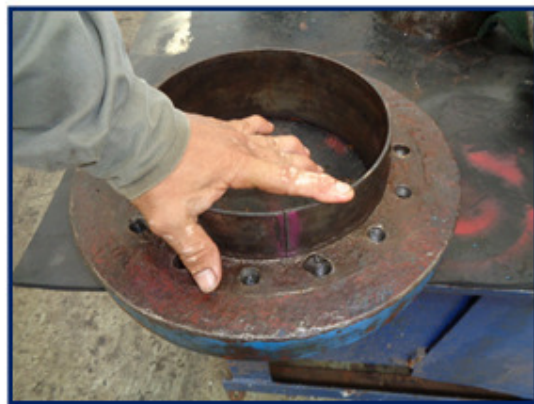
Completed machining of both (solid and hollow) shafts, crimp rings' coupling installed on hollow shaft was tested. The 16mm screws/bolts were torqued at 250 lb/ft shrinking the housing of hollow shaft by .004". Adjustment was agreed with client to be satisfactory.

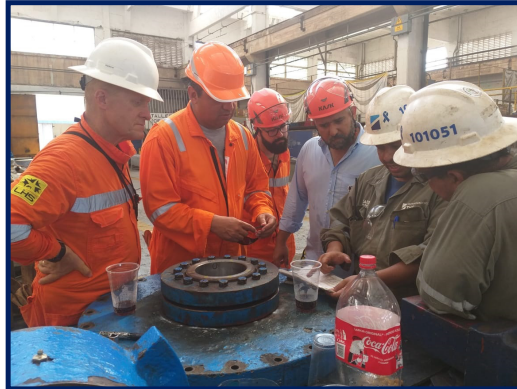
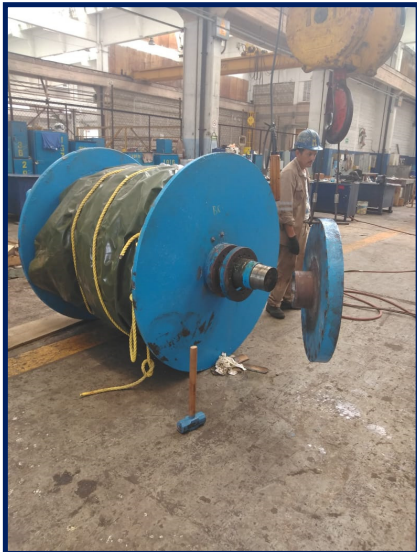
As for adjustment between the hollow shaft and solid shaft, both shaft measurements were checked, remaining with a slightly forced adjustment (the minimum diameter admitted was greater than the maximum diameter admitted for the hole), so slight heat had to be applied to the rear cover of the hydraulic motor to insert it into the winch's shaft.

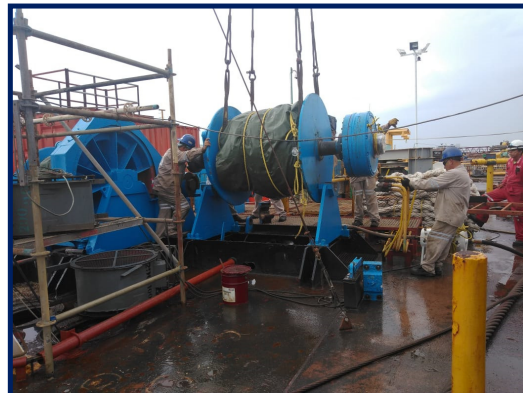
Winch was mounted and during the first tests performed with a load of less than 4 tons, the hydraulic motor moved the winch's shaft without any trouble; then, with a load of more than 4 tons, the hydraulic motor rotates and the winch's shaft-drum fails to move. Components were checked finding loose screws/bolts even though such had been torqued. A decision was made to change the fifteen 16 X 100 mm screws/bolts of the crimp rings' coupling along with the respective spring washers.

Having changed the 15 screws/bolts, these were torqued to 250 lb/ft and tests were performed once again with the same effect: with a load of less than 4 tons, the hydraulic motor moved the winch's shaft without any trouble; with a load of more than 4 tons, the hydraulic motor rotates and the winch's shaft-drum fails to move

Being there was no information from the client on the original adjustments there should be between the rear cover of the motor and winch shaft, it was estimated and agreed, by common consent client-supplier, that by machining the solid shaft, bushing the hollow shaft and adjusting and shrink-fitting hollow shaft to up to .004", the winch could end-up working satisfactorily. Unfortunately, the objective was not achieved.

A more forced adjustment would have to be obtained between both coupling parts to again test and check behaviour (trial and error) until the exact adherence is achieved, reason for which it is essential to count on the original settings from the client to avoid reworks.
