Siniat\Zona 1\Ventilatore Aria Circolazione 2 - 85\Motore\Punto 2 Ass.\103 Mach. spectr. >600

REM SRL  
Via Ferruccia, 16a  
03010 Patrica FR

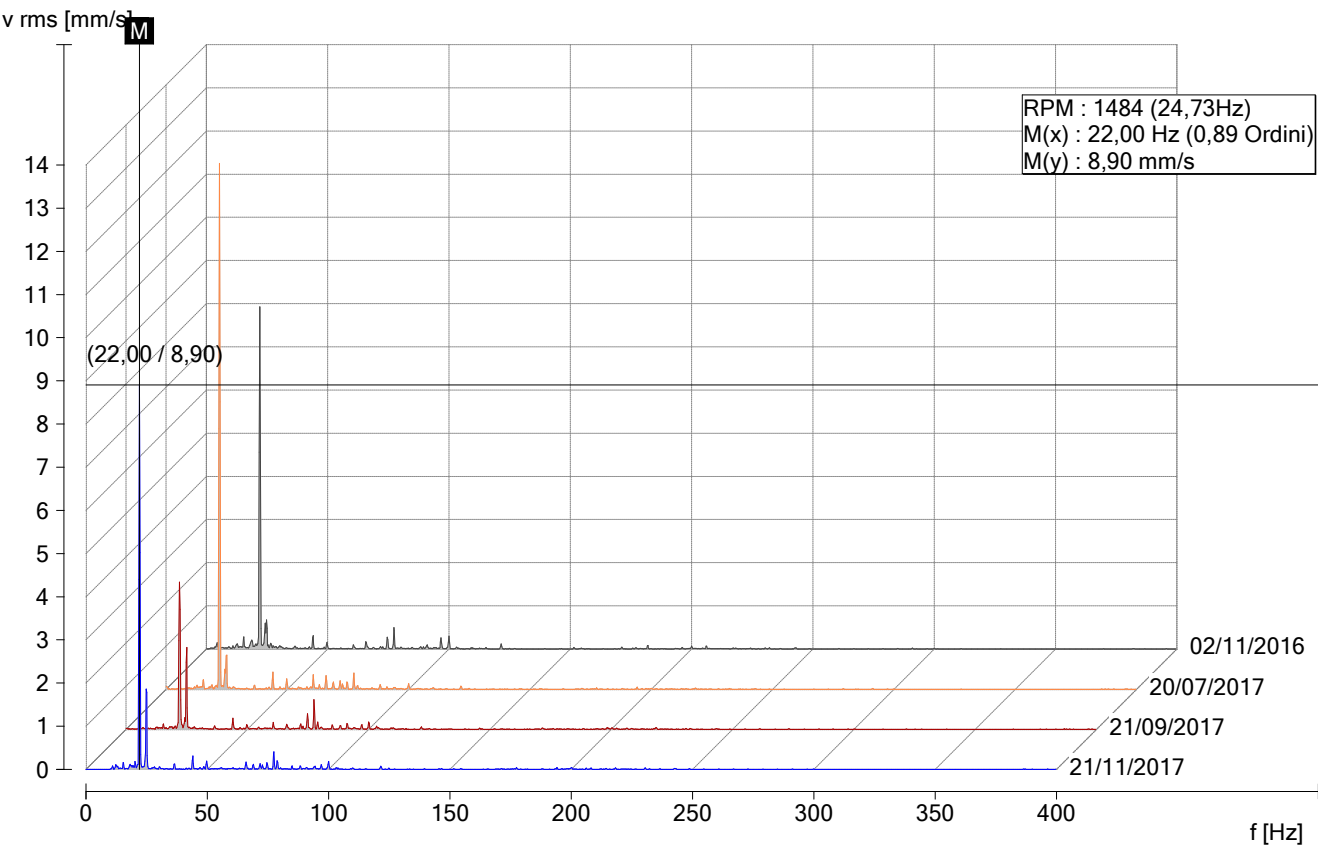
Data e ora della misurazione02/11/2016 10:40:05 ,20/07/2017 08:50:44 ,21/09/2017 08:37:24 ,21/11/2017 14:20:56

| Cursore<br>Principale | X [Hz] | = 22,00 | (76,33) BPFO 6316 (SKF) |
| | Y [mm/s] | = 8,90 | (121,54) BPFI 6316 (SKF) |
| | | = 1484 | (88,67) BPFO 6319 (SKF) |
| | | | (188,34) BPFO 22220E (SKF) |
| | | | (256,86) BPFI 22220E (SKF) |
