**FIELD REPORT:** Vessel S45, Contract Number R-1609

Work Order WE003, Item 8001

**FIELD REPORT:** Vessel S45, Contract R-1609

Component damage repairs

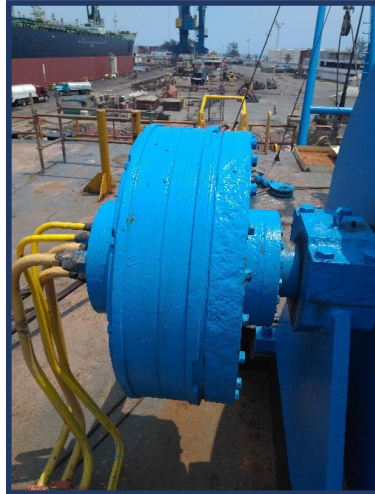
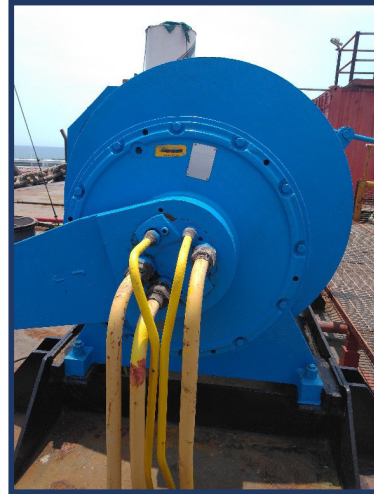
The following activities were carried out to attend the request to check and provide a diagnosis of why the hydraulic motor of the bow centerline mooring winch rotated but did not haul the drum shaft: [http://www.olagorta.com/Radial\\_VI.pdf](http://www.olagorta.com/Radial_VI.pdf)
