**R.E.M. s.r.l.**

**Misurazioni Sede**

Commesso: 2022-0114

SIEMENS 1LA8317

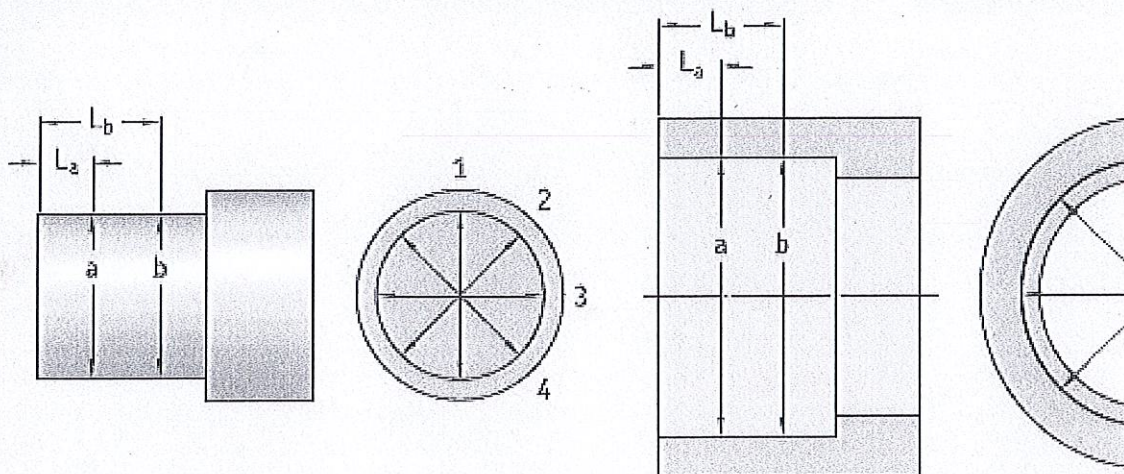
6218 C3

RIP. SEDE L. OPPOSTO VENTOLA SU CALOTA LATO A

| Measuring directions | Shaft<br>Measurement values [mm]<br>at place | | | | Housing<br>Measurement values [mm]<br>at place | | |
|---|---|---|---|---|---|---|---|
| 1 | | | | | <u>160,020</u> | | |

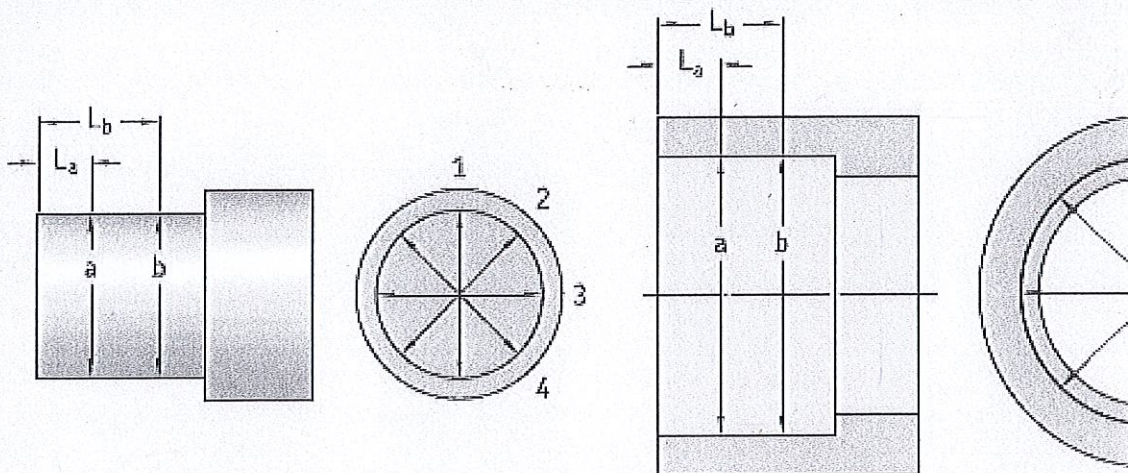
6218 C3 J20 AA

LATO VENTOLA RIP. SEDE SU CALOTTA LATO B

| Measuring directions | Shaft<br>Measurement values [mm]<br>at place | | | | Housing<br>Measurement values [mm]<br>at place | | |
|---|---|---|---|---|---|---|---|
| 2 | | | | | <u>160,020</u> | | |
