**Misurazioni Sede**

Commessa: 2022-0117

RIPARAZIONE SEDE CALOTTA L. VENTOLA (LATO B)

SIEMENS 1LA8317-2PC80-ZB3

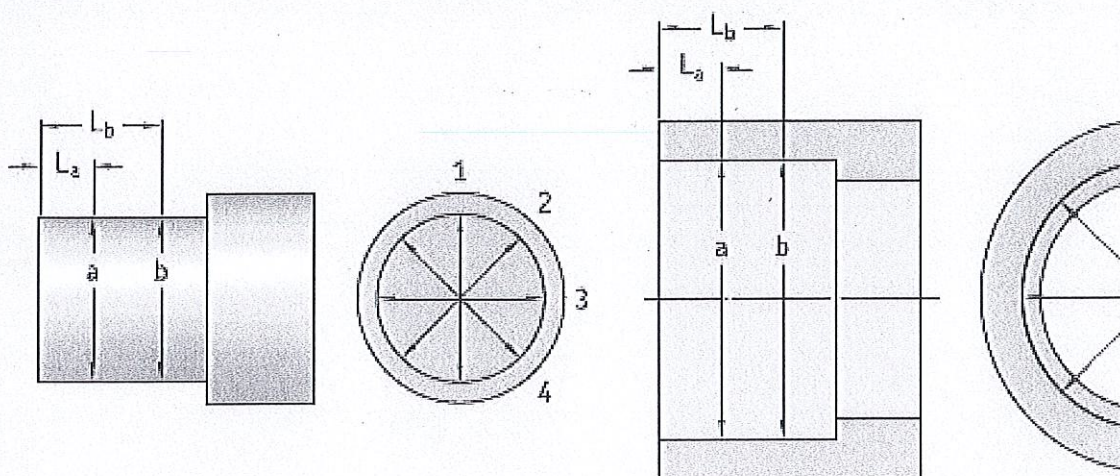
Bearing:

6218 C3

Bearing position:

| Measuring directions | Shaft<br>Measurement values [mm]<br>at place | | | | Housing<br>Measurement values [mm]<br>at place | | |
|---|---|---|---|---|---|---|---|
| 1 | | | | | 160,020 | | |

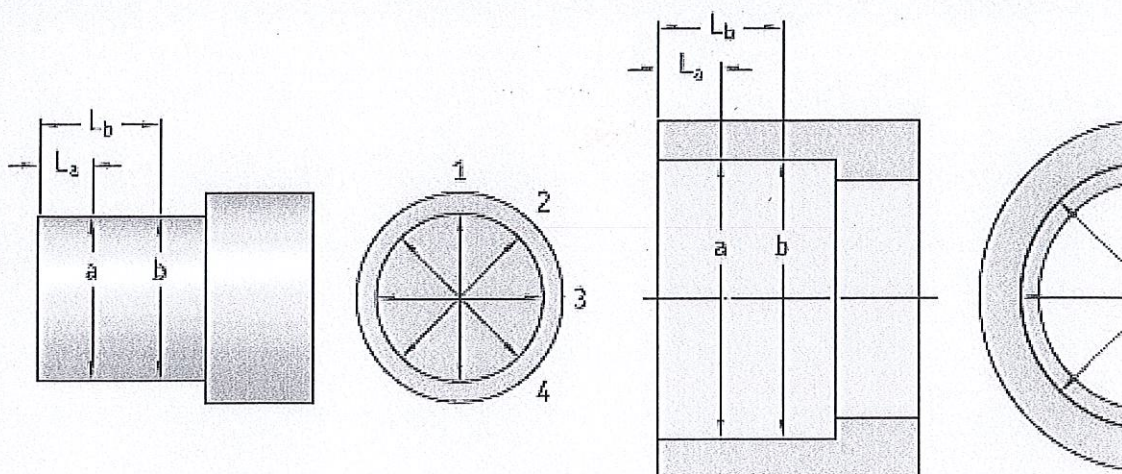
Bearing:

6218 C3

Bearing position:

RIPARAZIONE SEDE CALOTTA L. GIUNTO (LATO A)

| Measuring directions | Shaft Measurement values [mm] at place | | | | Housing Measurement values [mm] at place | | |
|---|---|---|---|---|---|---|---|
| 1 | | | | | 160,010 | | |
