**Misurazioni Sede**

Commessa: 2022-0118  
NUM. REM. 000000015641

Measurement report form

EFD 2DPIC280M/2N

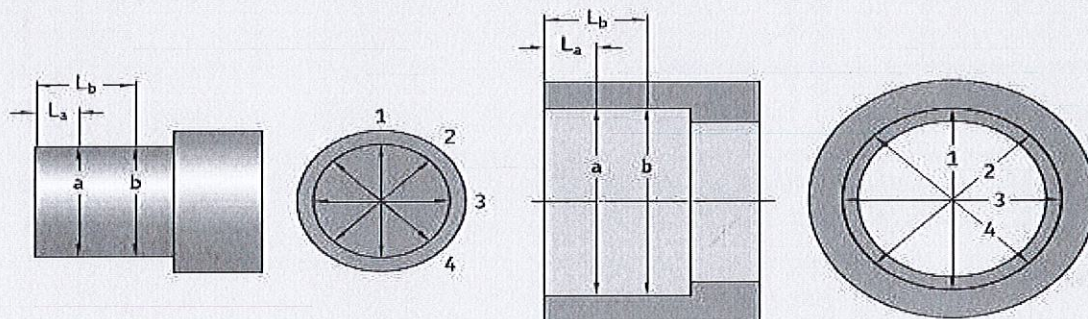
Bearing:

6315 C3

Bearing position:

RIPARAZIONE SERIE CALOTTA 2. VENTOLA (LATO B)

| Measuring directions | Shaft Measurement values [mm] at place | | | | Housing Measurement values [mm] at place | | | |
|---|---|---|---|---|---|---|---|---|
| 1 | | | | | <u>160,010</u> | | | |

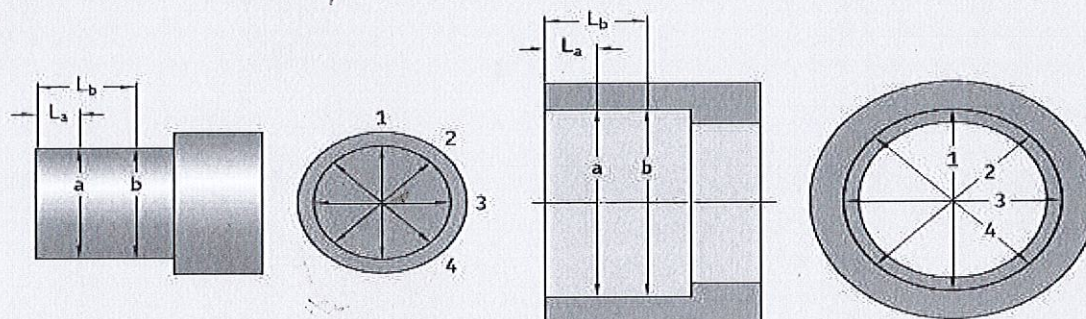
Bearing:

6315 C3

Bearing position:

RIPARAZIONE SEDE CALOTTA L. GIUNTO (LATO A)

| Measuring directions | Shaft Measurement values [mm] at place | | | | Housing Measurement values [mm] at place | | | |
|---|---|---|---|---|---|---|---|---|
| 1 | | | | | <u>160,020</u> | | | |
